MS4 Permit Requirements and Inspection/Maintenance of Stormwater Management Facilities

Presented to Hamilton Township

Rutgers Cooperative Extension Water Resources Program
Chris Obropta and Matt Lecone

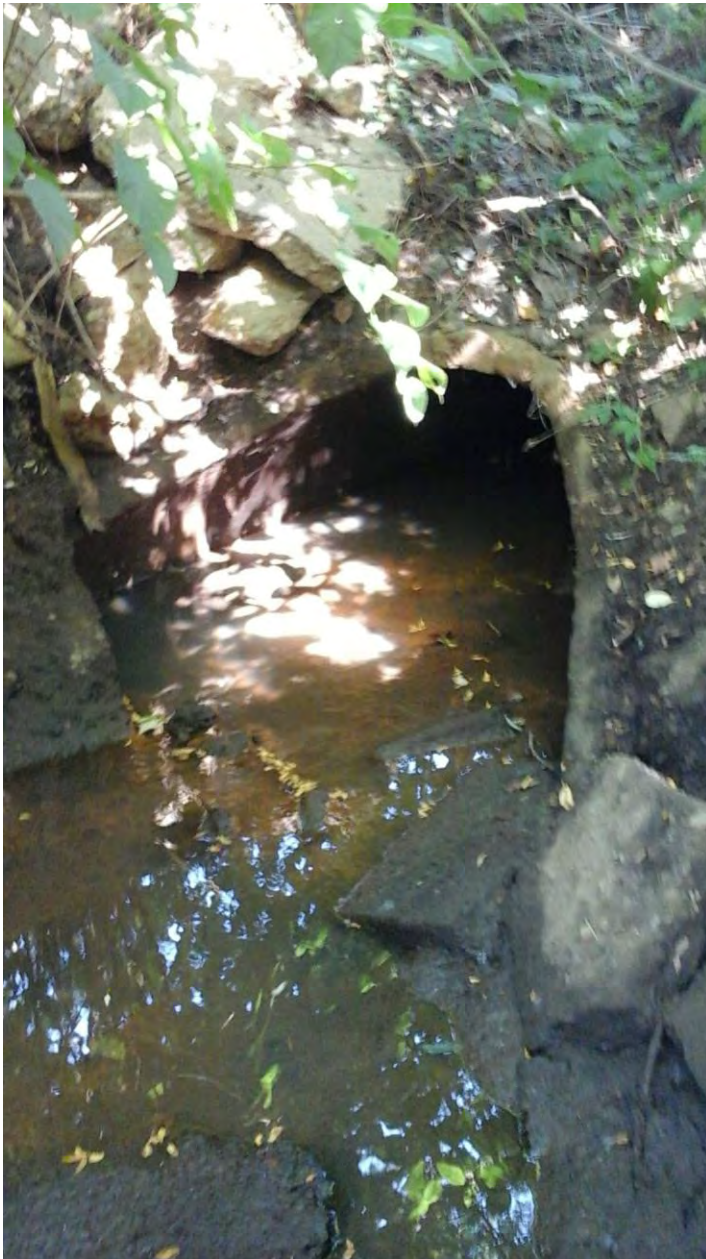
Rirap Apron

TAILWATER $\geq 0.5 D_o$

$$L_a = 1.8(q / D_o^{0.5}) + 7D_o$$

$$q = Q/W_o$$

- Fix scouring problems per appropriate solutions
 - Riprap apron, scour hole, riprap channel, rock/gabion flume
 - Anything at High and Medium Erosion should be planned for repair prioritizing highest erosion first
 - Minor monitored in future inspection

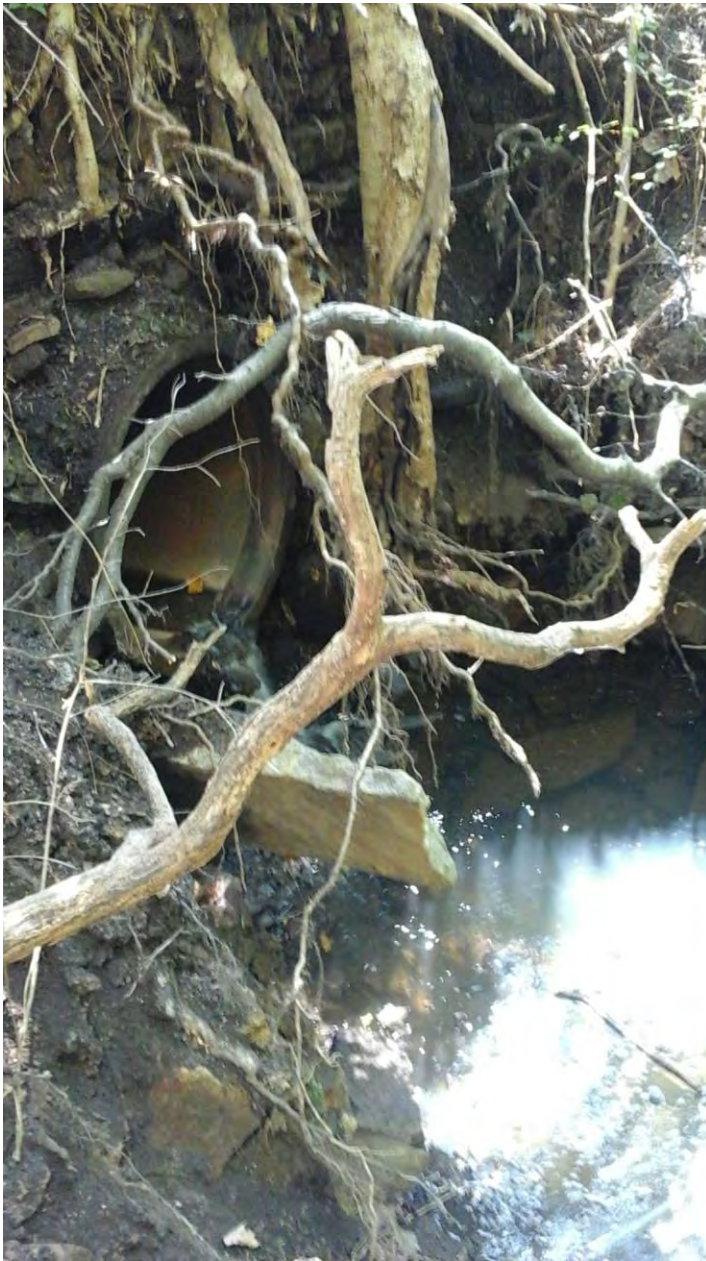
Scour Hole

G506

PLAN

SECTION

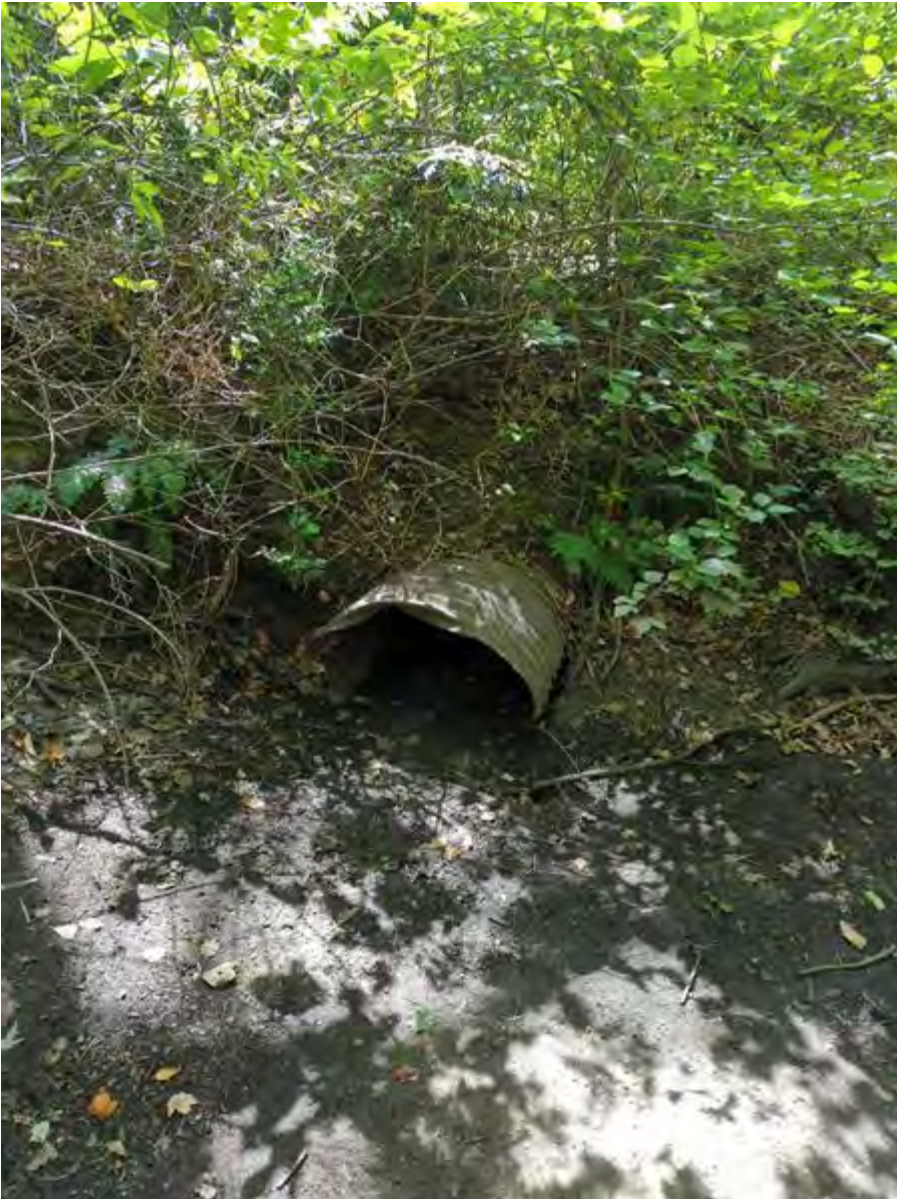
Remove
Sediments

- Repair Outfall Structures
 - Remove sediments to restore conveyance, stabilize base structure, reconstruct outfall structure
 - Anything with major or moderate cracking should be planned for repair prioritizing highest erosion first, minor monitored in future inspection
- Designs to be developed for AC09 and MR33

MR77	E0201	Y	34	Metal			8/16/2022	Needs Maintenance		2 - Moderate Cracking or Corrosion	partially filled with sediment, pipe corroding	4 - High
MR80	D0206	Y	24	Metal			7/22/2022	Needs Maintenance	Needs Stabilization	2 - Moderate Cracking or Corrosion	Very hidden, some undermining, pipe to the left	3 - Medium
MR88	D0202	Y	34	Concrete			7/22/2022	Needs Maintenance	Good	2 - Moderate Cracking or Corrosion	Lots of sediment, 6 inches sediment	3 - Medium
MR94	E0214	Y	13	Concrete			7/22/2022	Needs Maintenance	Needs Stabilization	2 - Moderate Cracking or Corrosion	mostly covered with sediment	3 - Medium

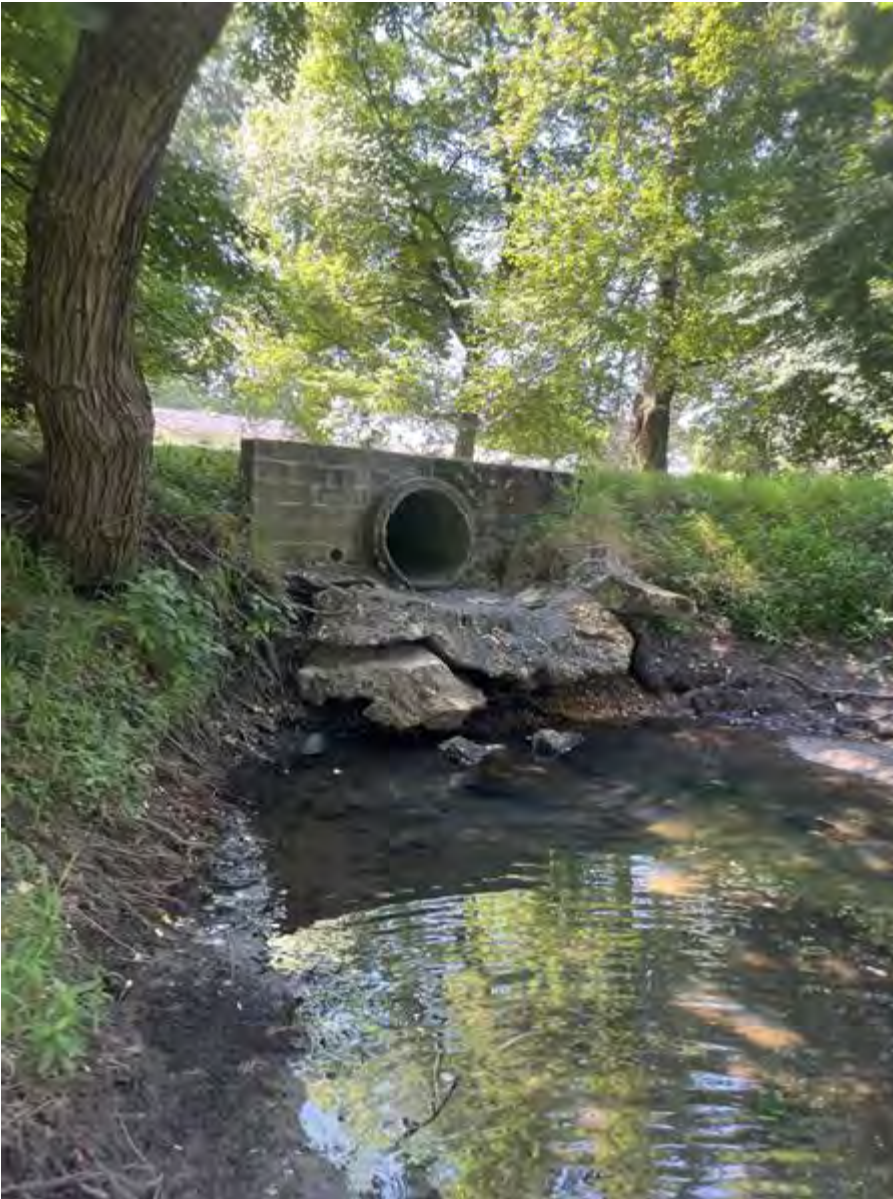
Stabilize Structure

MR51	C0204	Y	36	Concrete			7/22/2022	Needs Repair	Fair	3 - Major Cracking or Corrosion		4 - High
MR62	C0213	Y	30	Concrete			7/22/2022	Needs Repair	Fair	3 - Major Cracking or Corrosion	Portion of pipe unseated, some erosion control in the form of sticks and stones placed at outfall preventing worse erosion	3 - Medium
MR69		Y	30	Concrete			8/16/2022	Needs Repair	Fair	3 - Major Cracking or Corrosion	Pipe is cracked and disconnected	4 - High
MR93		Y					8/4/2022	Needs Repair	Needs Stabilization	3 - Major Cracking or Corrosion		4 - High
MR01		Y	40	Concrete			8/4/2022	Needs Maintenance	Fair	2 - Moderate Cracking or Corrosion		3 - Medium
MR17	B0313	Y	18	Metal			7/21/2022	Needs Repair	Needs Stabilization	2 - Moderate Cracking or Corrosion	Undermining; pipe is half buried with sediment; overall structure is collapsing	4 - High
MR26	B0322	Y	6	Concrete			7/21/2022	Needs Maintenance	Needs Stabilization	2 - Moderate Cracking or Corrosion	pipe subsided into stream	3 - Medium

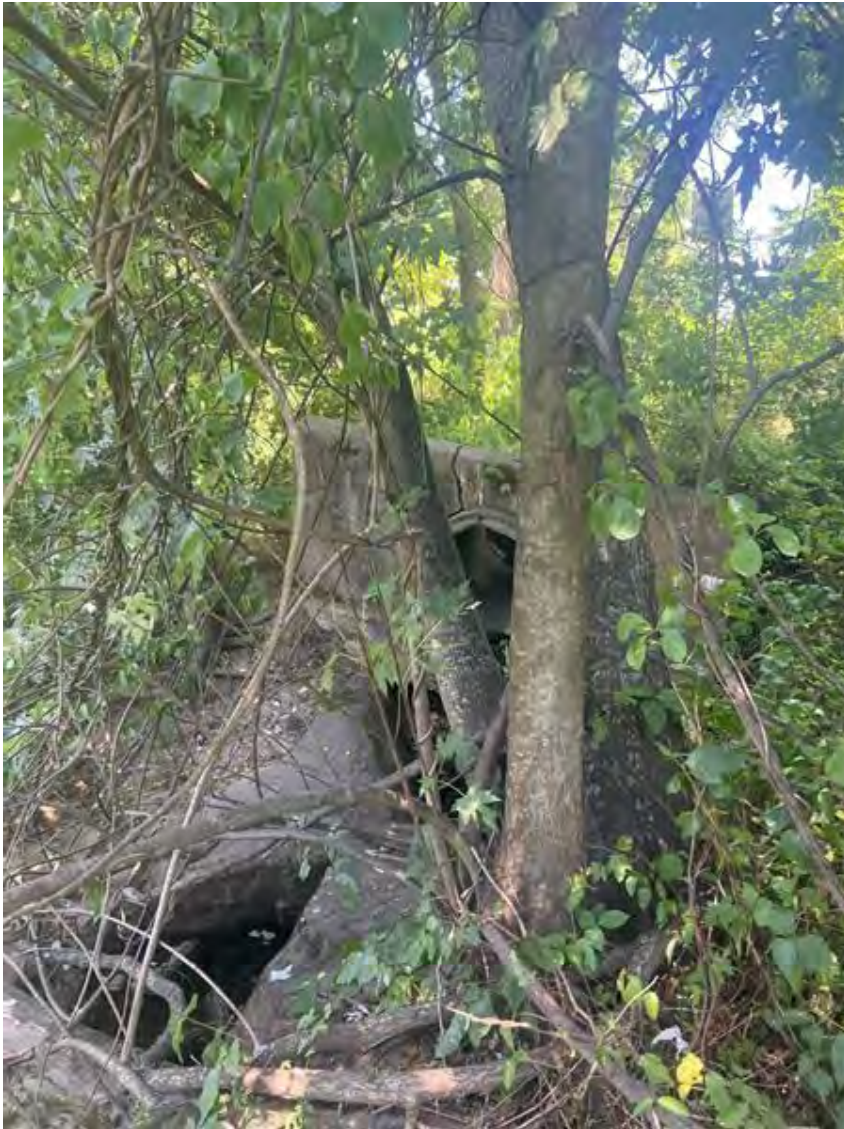
AC09

Reconstruct Outfall or Headwall

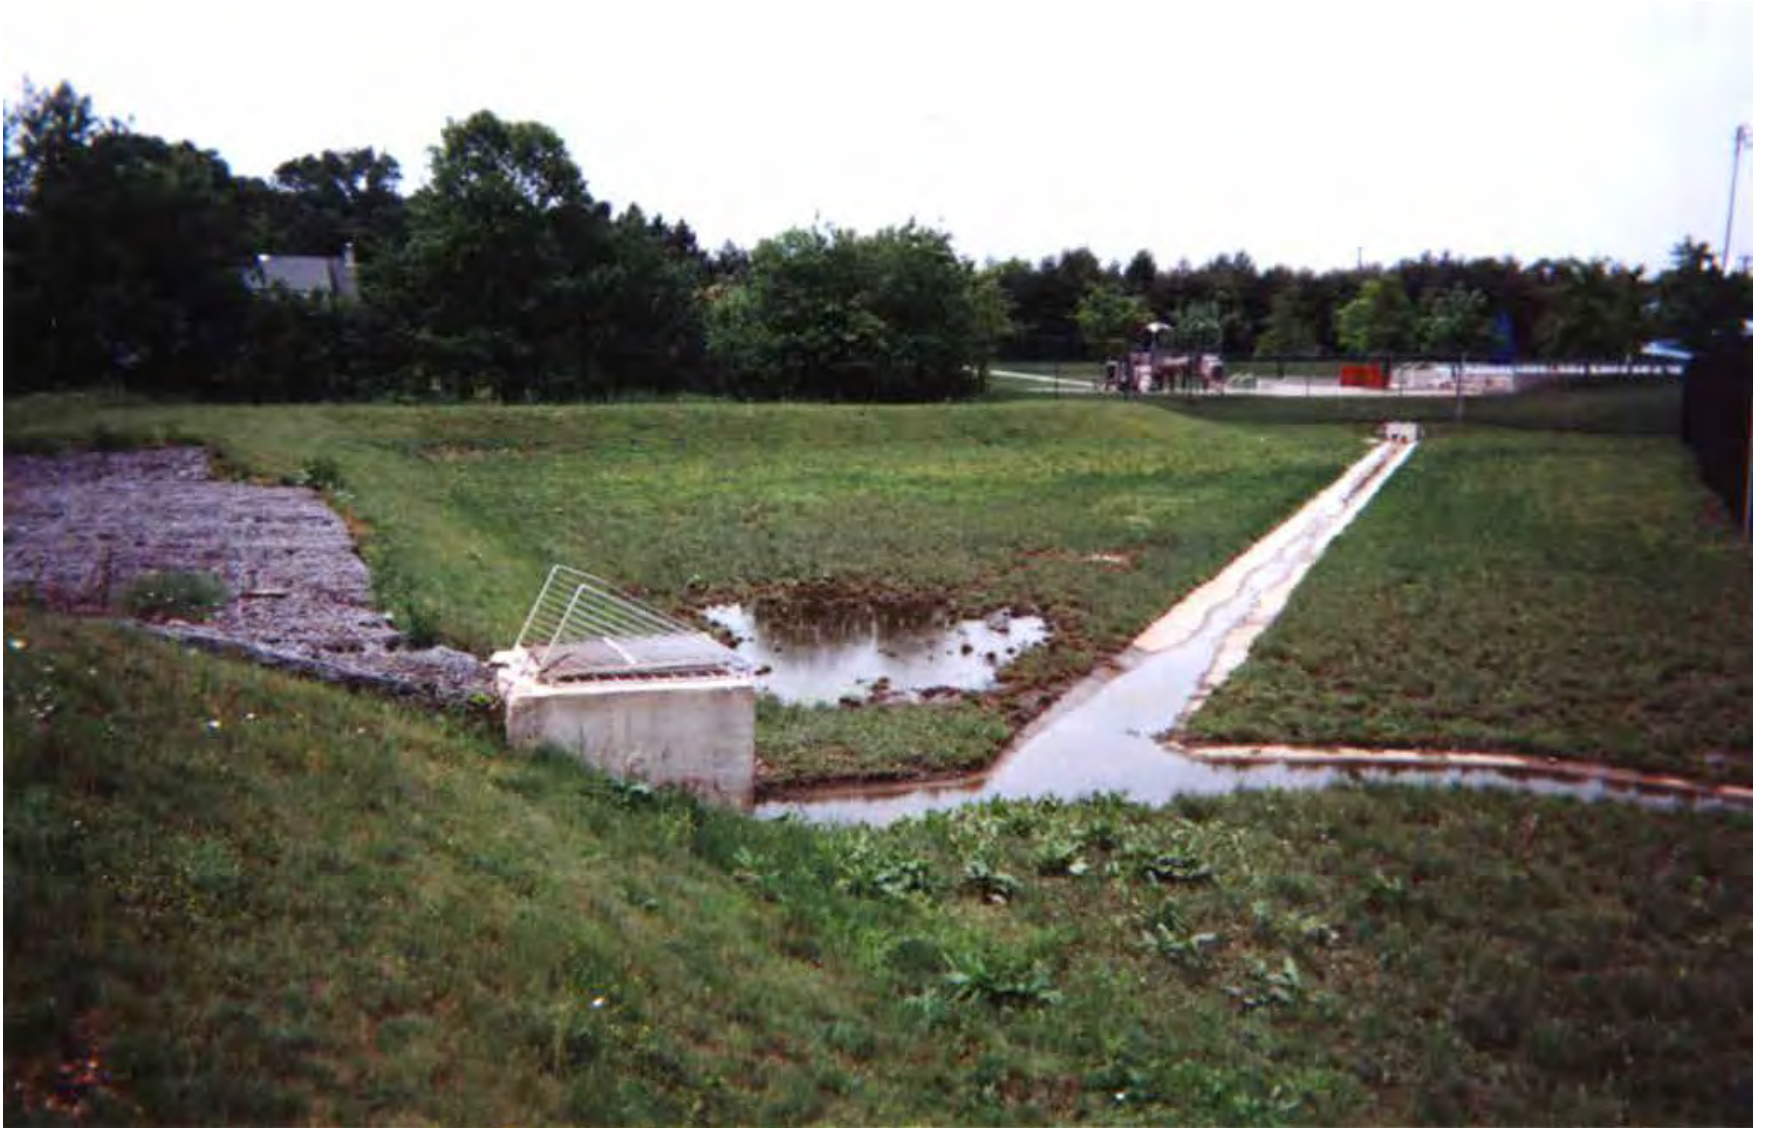
Typical Detention Basin

Detention basins are designed to detain stormwater runoff during a storm and slowly release the stormwater after the storm.

- Prevents downstream flooding
- Removes pollutants only through settling
- Typically goes dry 48-hours after storm
- Usually contains turf grass that is regularly mowed
- Often contain concrete low-flow channel
- Follow old regulation standard

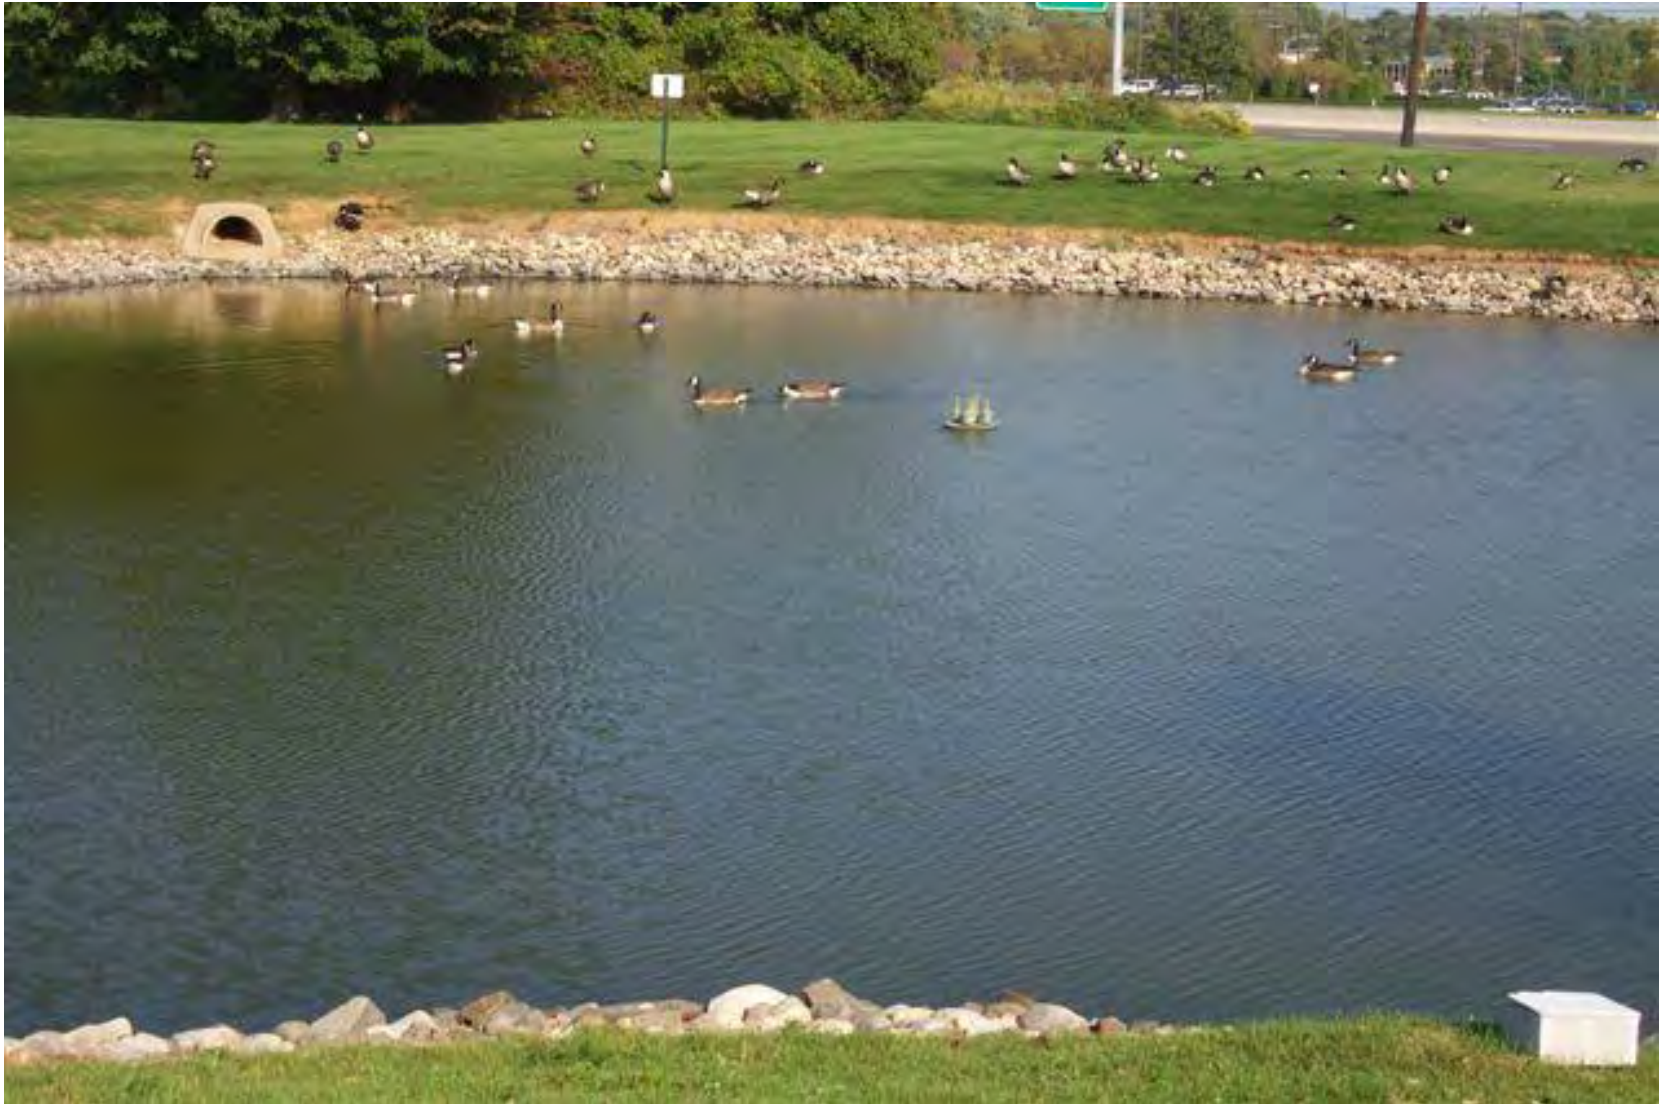
Typical Detention Basin

Typical Retention Basin

Retention basins maintains permanent pools and stores stormwater runoff on tope of existing standing water.

- Prevents downstream flooding
- Removes pollutants mainly through settling and algal uptake
- Always has a minimum of three feet of standing water
- Often attract lots of geese
- Can require dredging

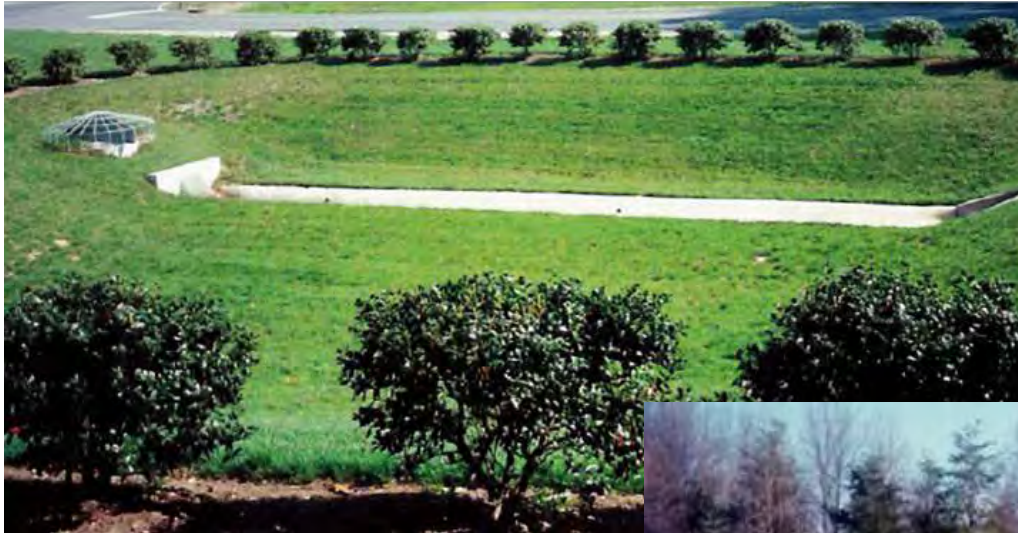
Does the basin hold a permanent pool of water?

NO – Detention/Infiltration

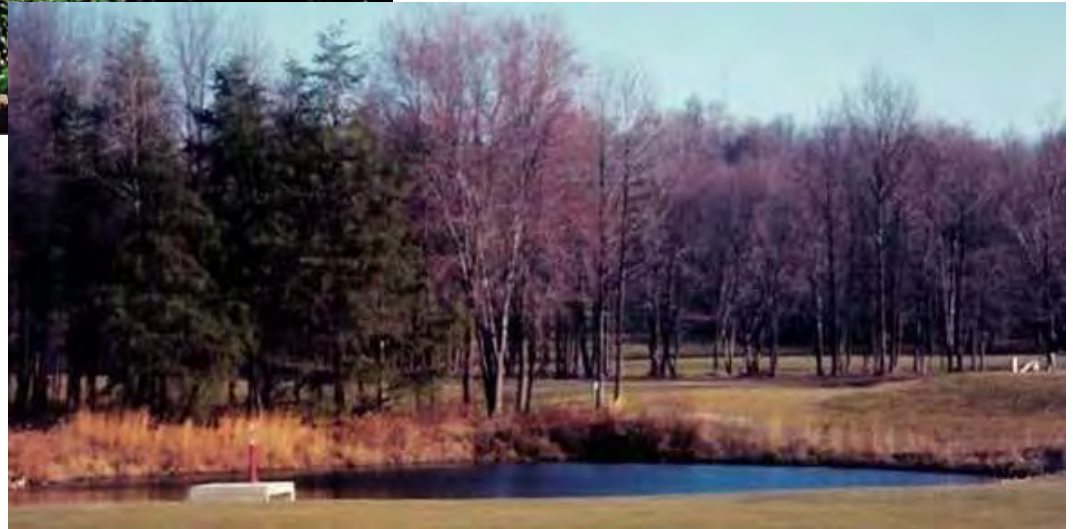
YES – Retention

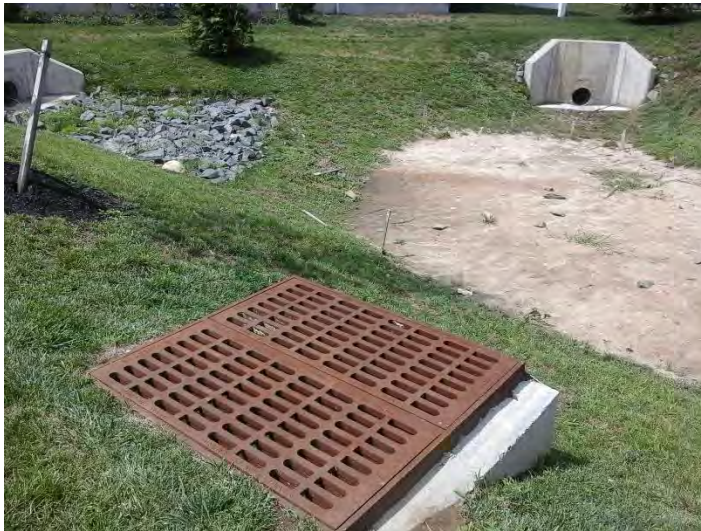
Is the basins primarily outlet at the bottom of the basin or does the basin have a low flow channel?

NO – Infiltration

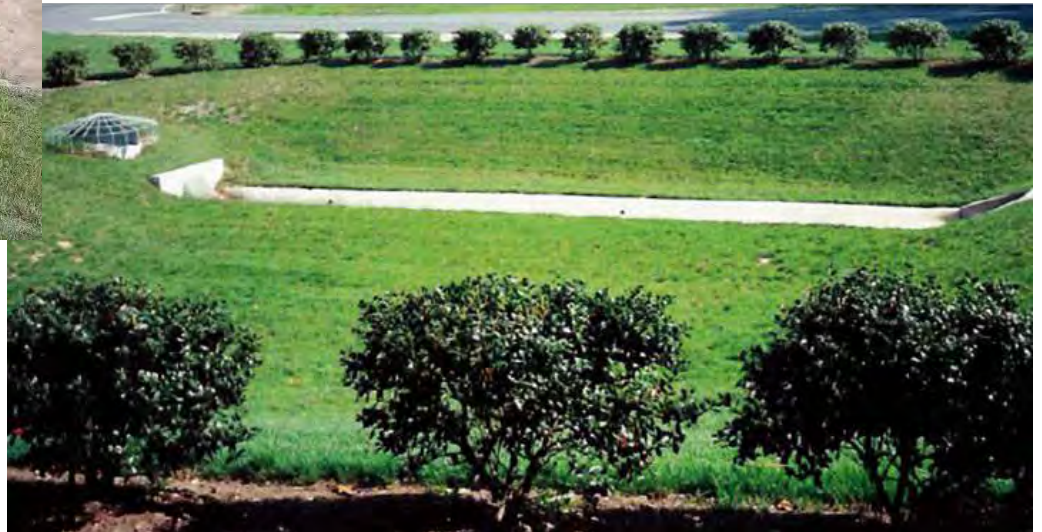
YES – Detention

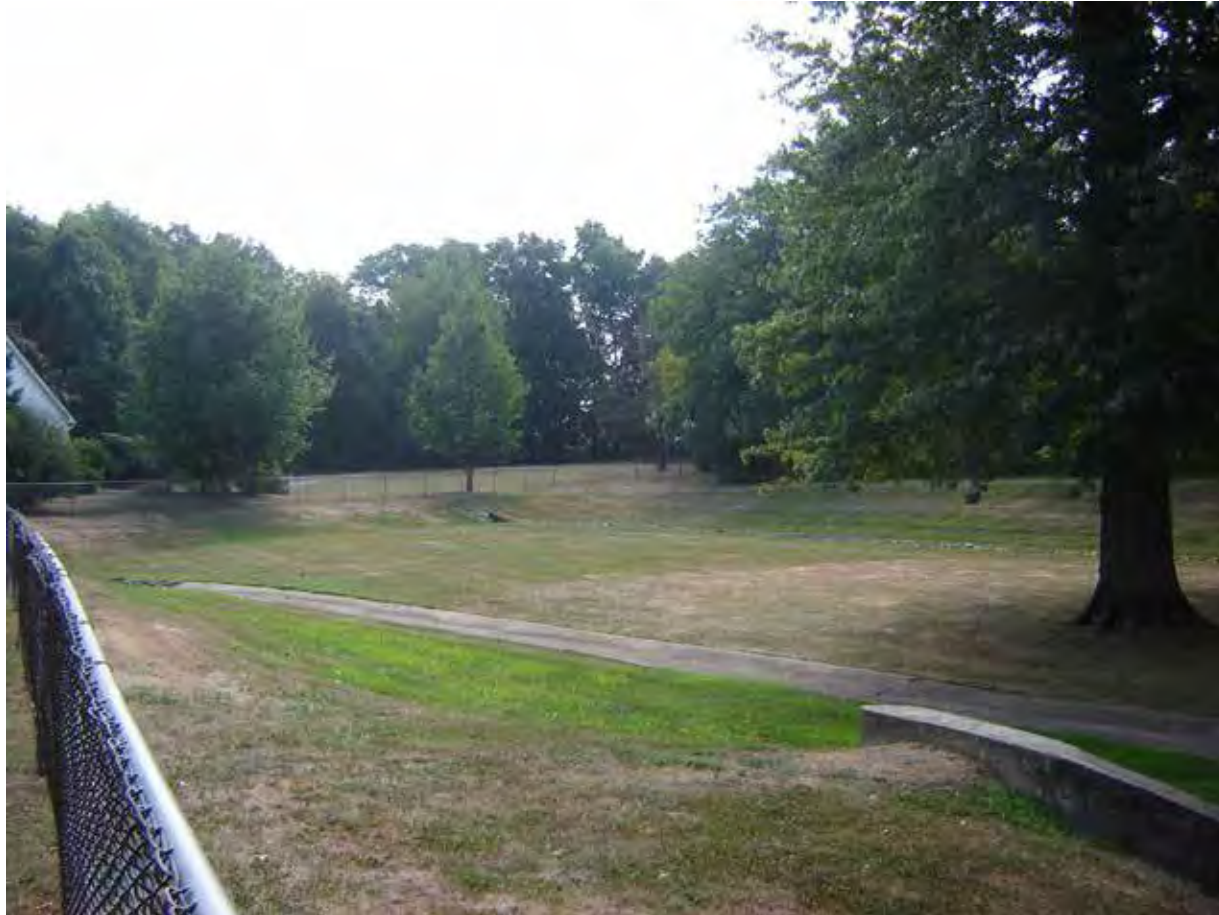
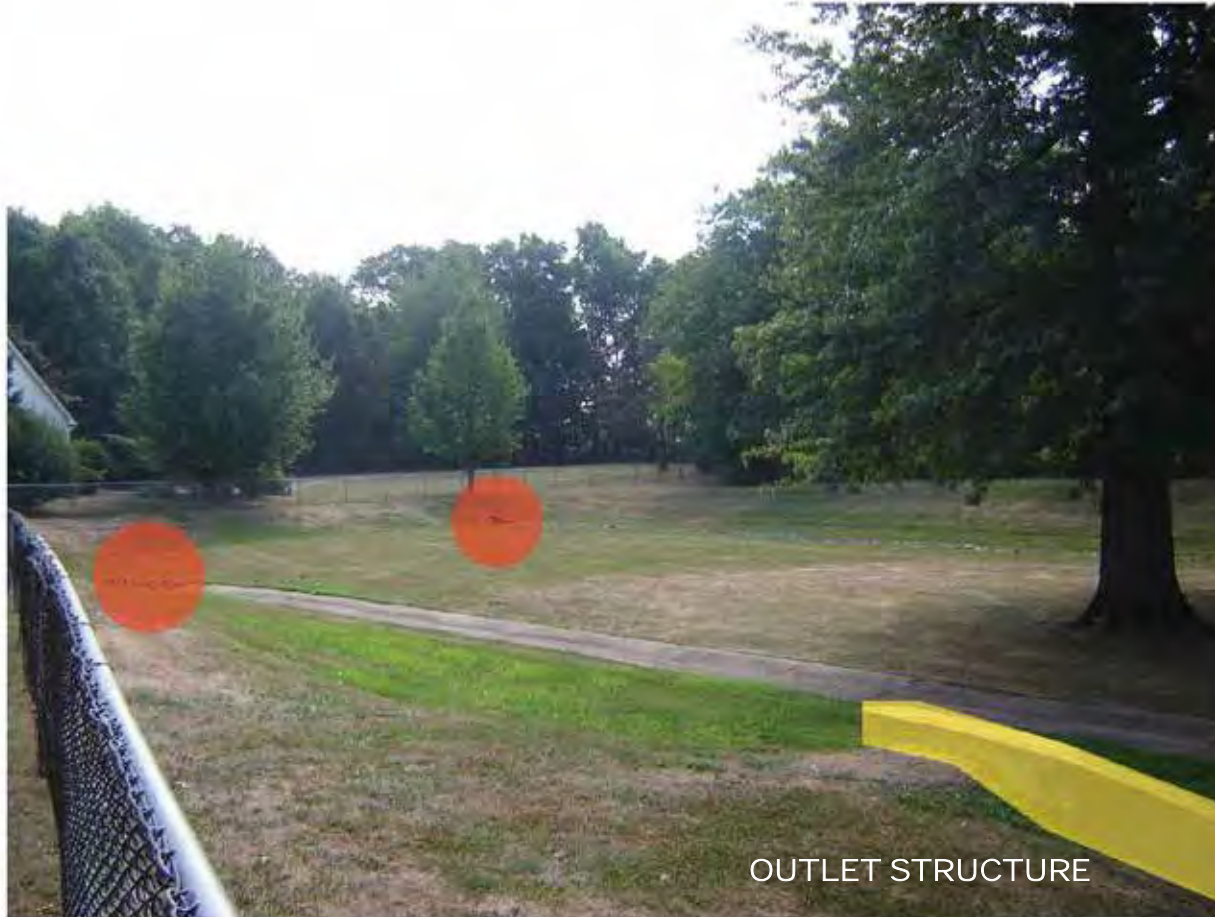
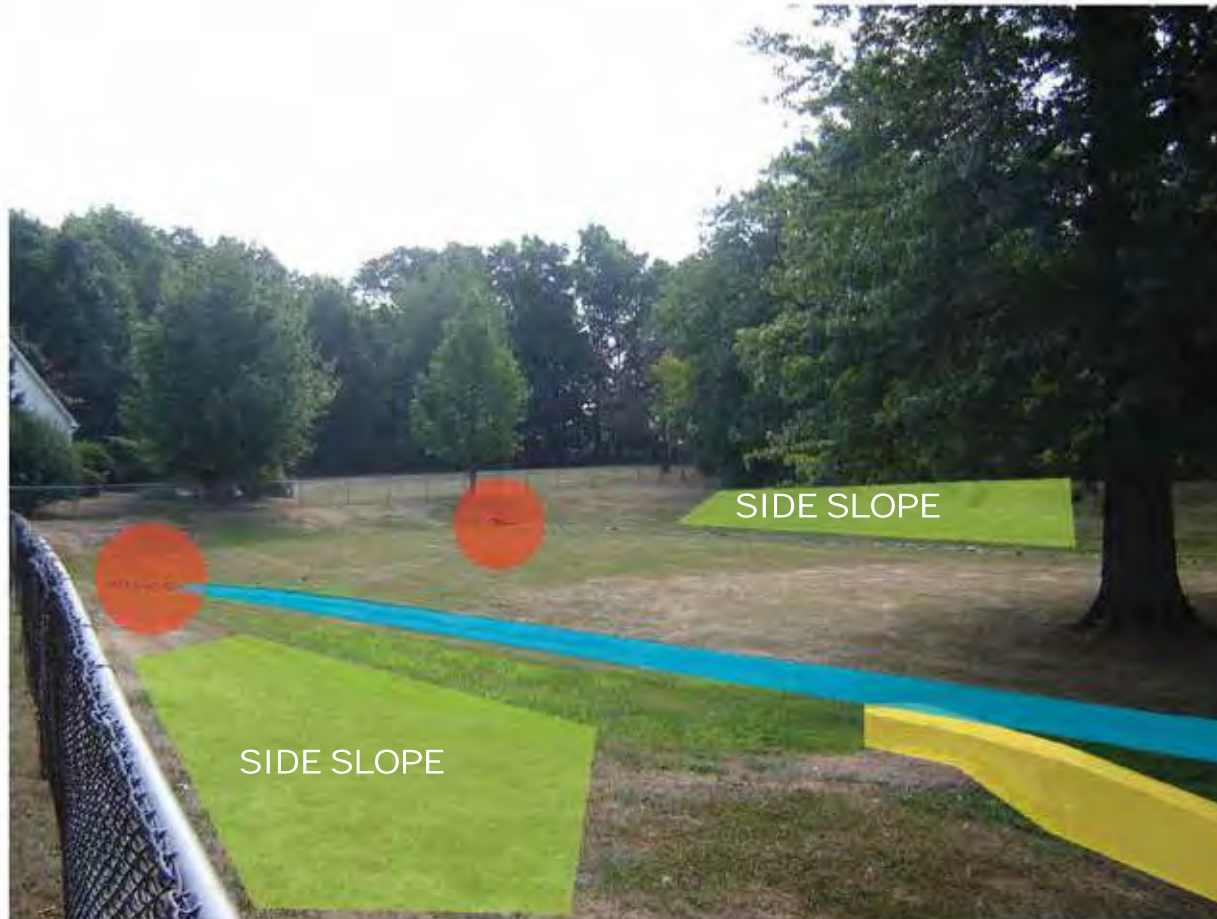
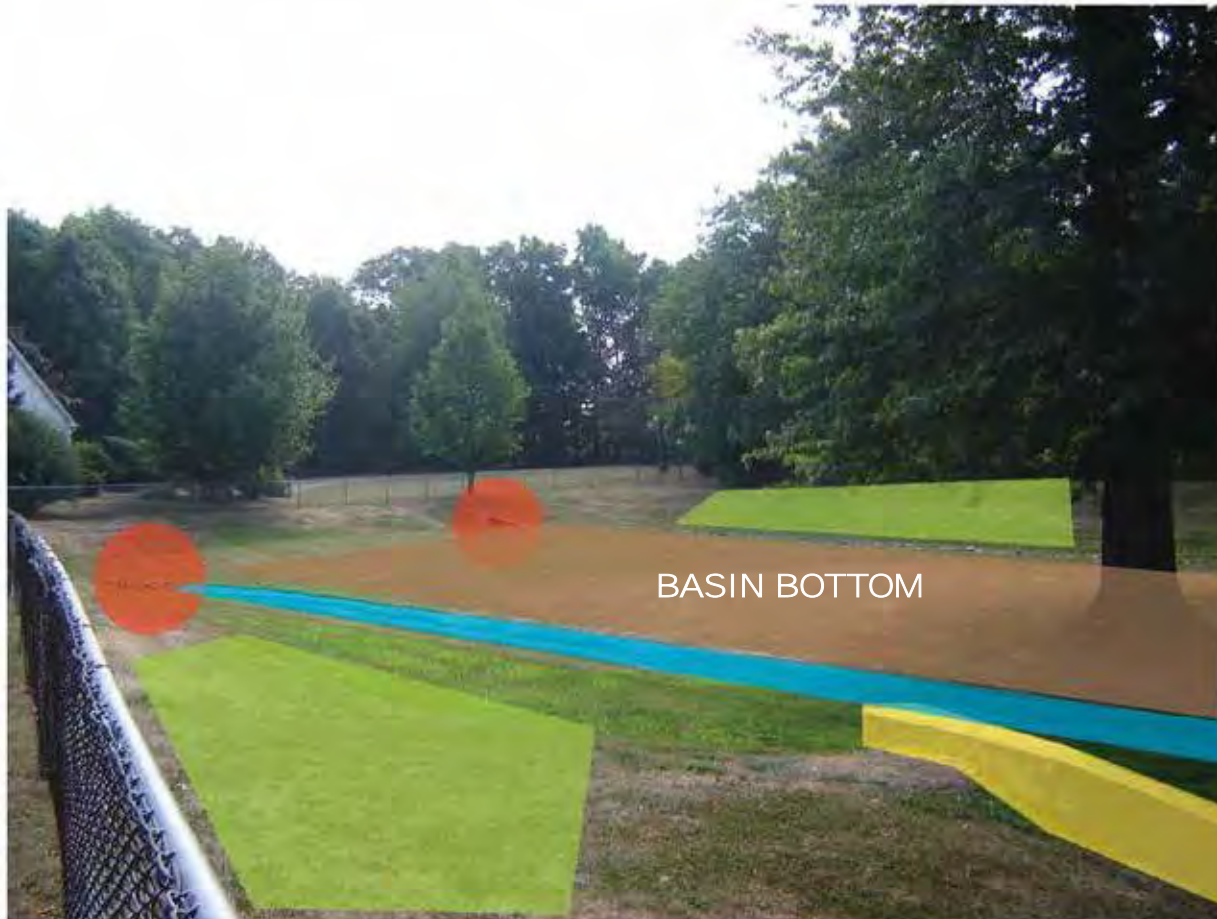
Detention Basin Anatomy

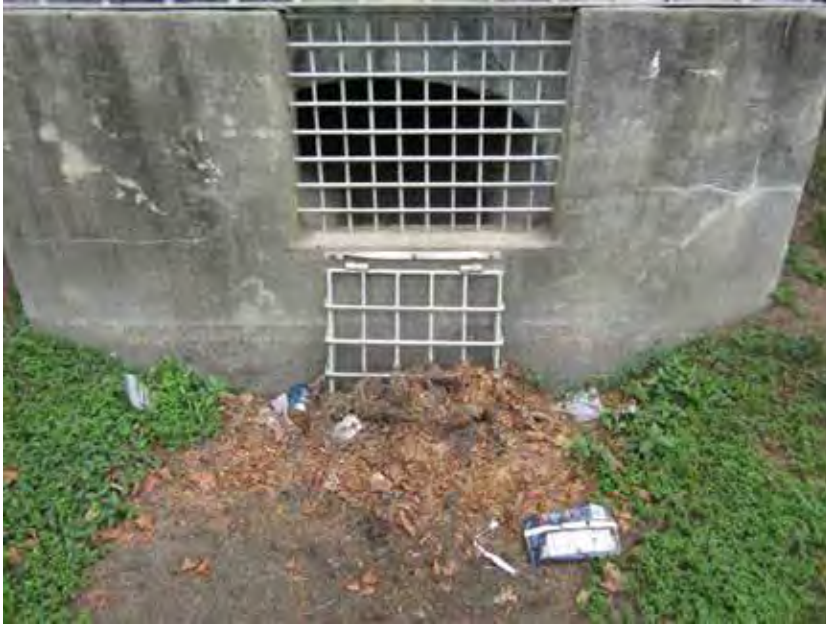
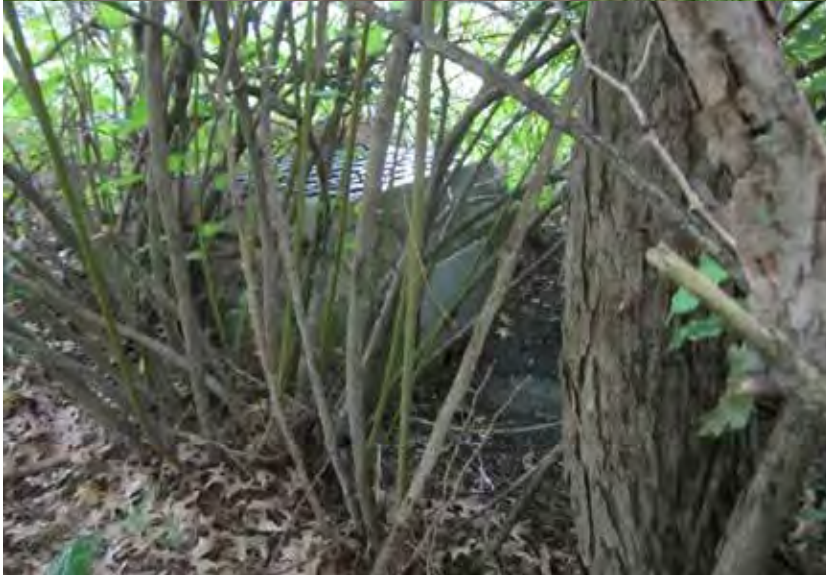
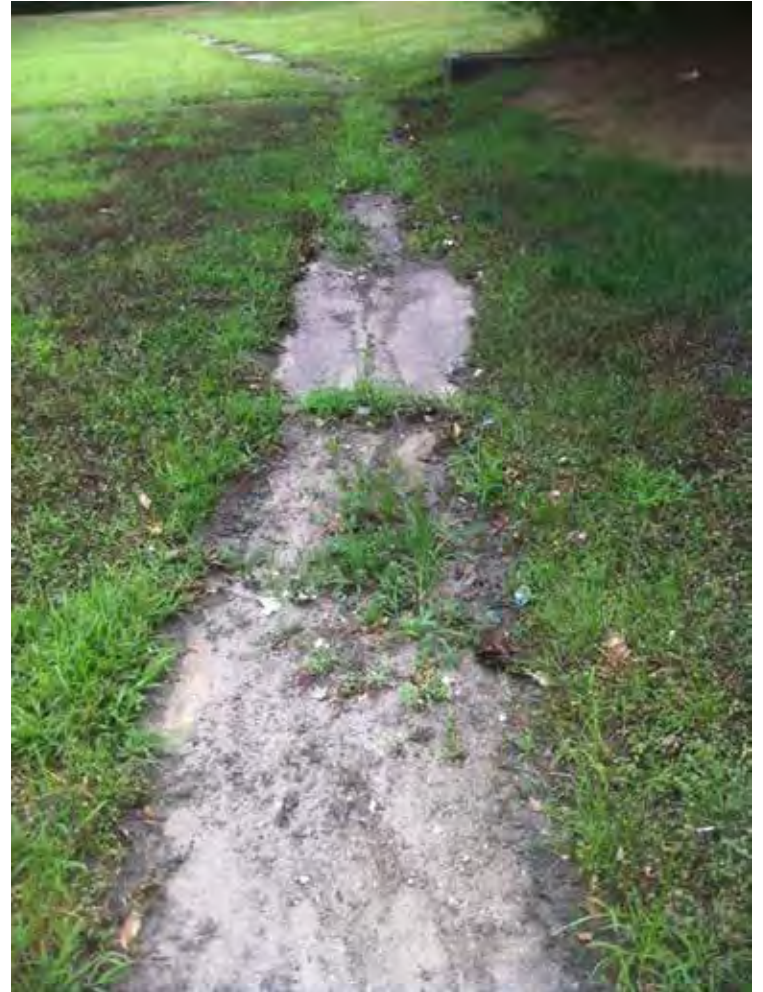
Routine Maintenance

- **Vegetation management**
 - Mowing should be done where/when it is needed (traditionally, 10-14 times per year)
 - Effective groundcovers must be kept healthy to prevent erosion and damage to the system
- **Debris and litter removal**
 - Inlets and outlets should be regularly cleared of debris and litter to prevent obstructions and reduced efficiency of the system
- **Mechanical components maintenance**
 - All mechanical equipment, such as gates, valves, locks, or other components must be kept in working order should an emergency arise

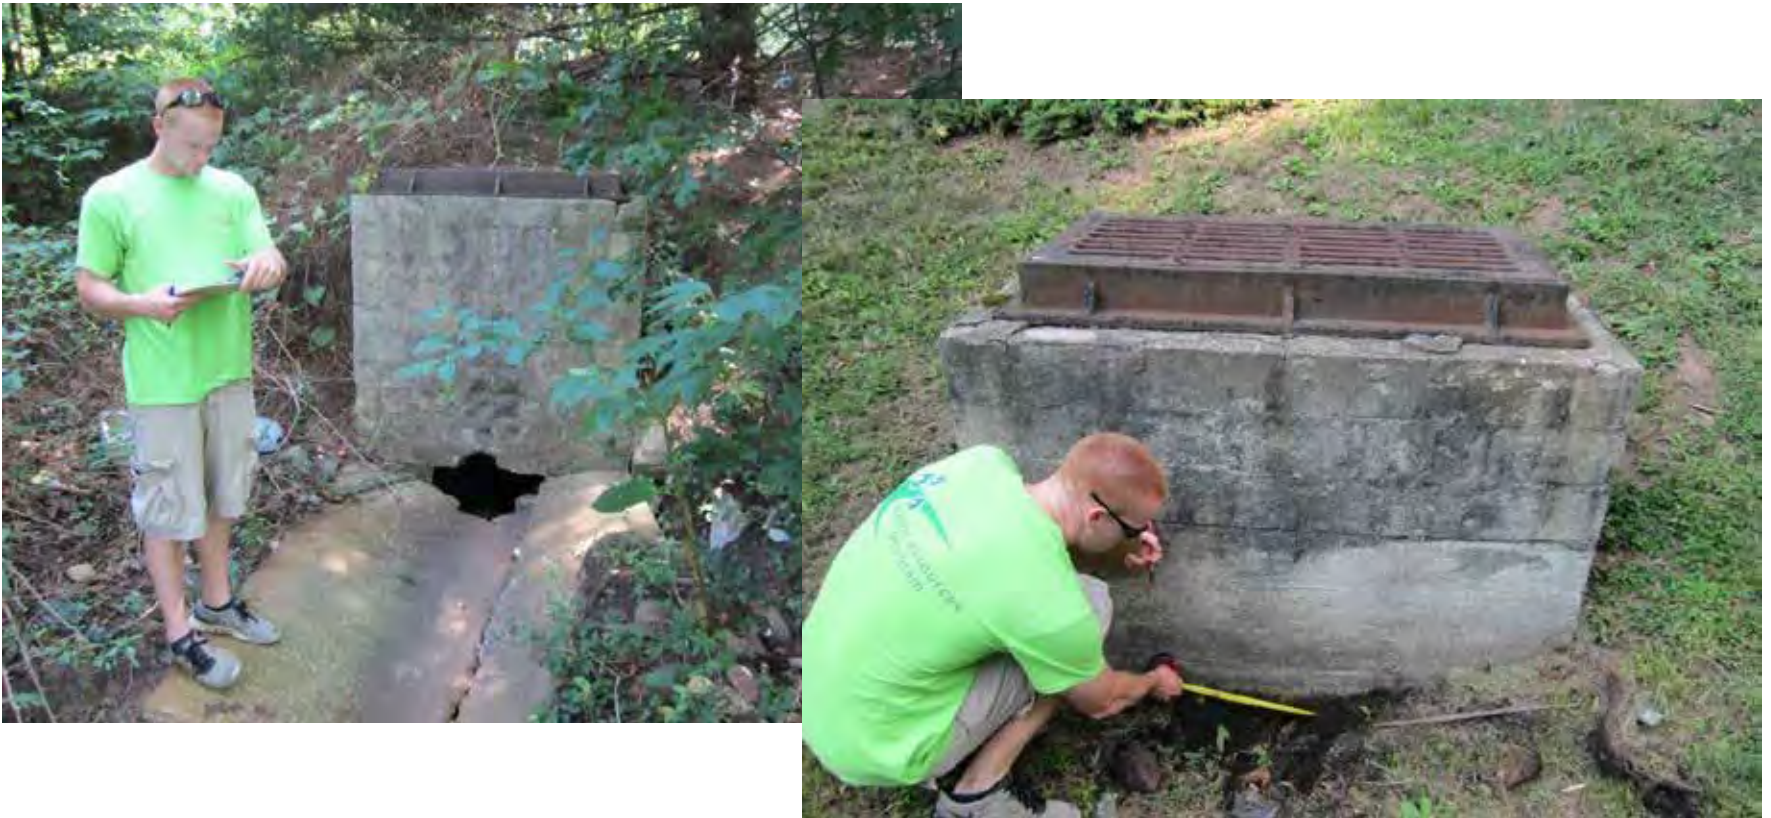
Routine Maintenance for Mechanical Components

- Regular inspections will reduce need for major replacements

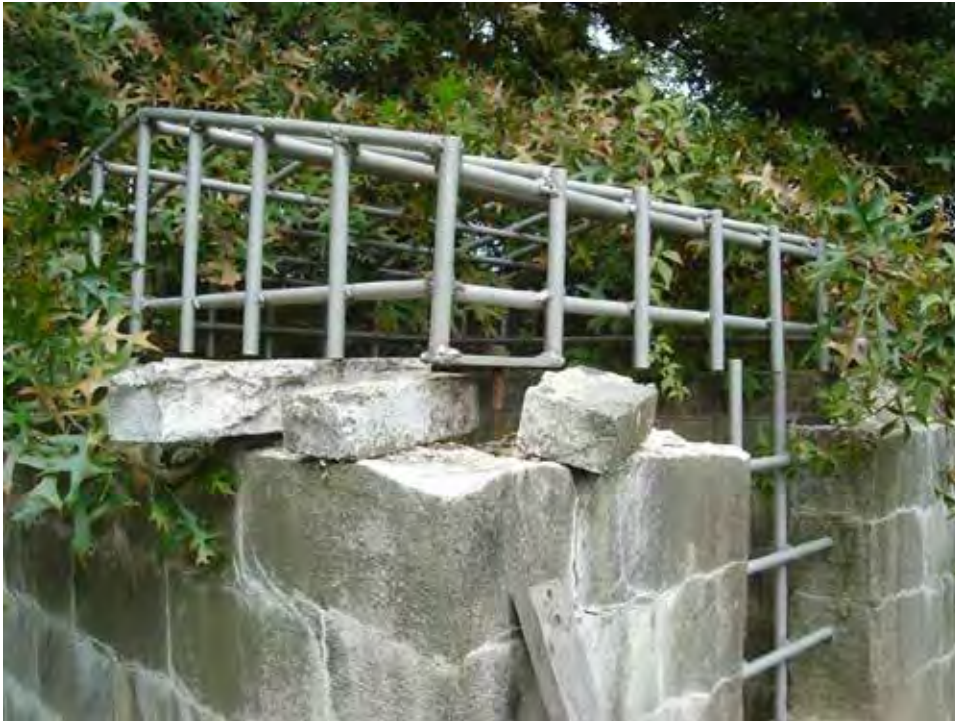
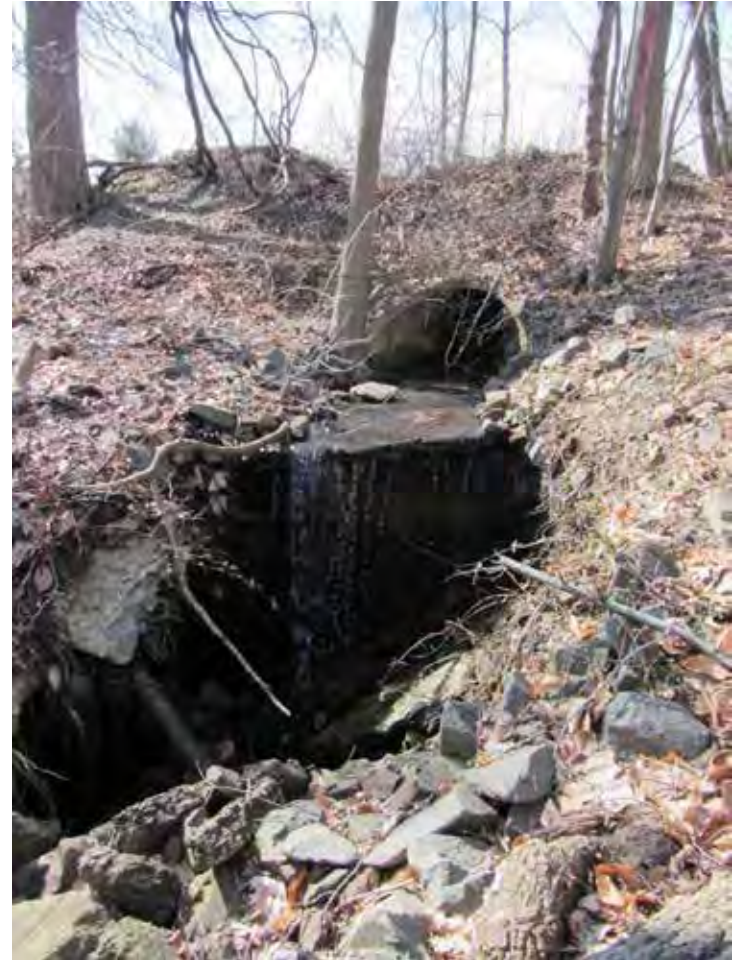
Non-Routine Maintenance

- Stabilization and erosion control repairs
 - If vegetation fails on embankments or in the basin, soil replacement, reseeding and stabilization should occur immediately
- Sediment removal
 - During the establishment of a new basin, the basin should be inspected for excessive sedimentation. After establishment, the basin should be inspected twice a year and excessive sediment accumulated in the basin should be removed.
- Outlet repair or replacement
 - Should the system stop functioning as designed the outlet structure may require repair or replacement

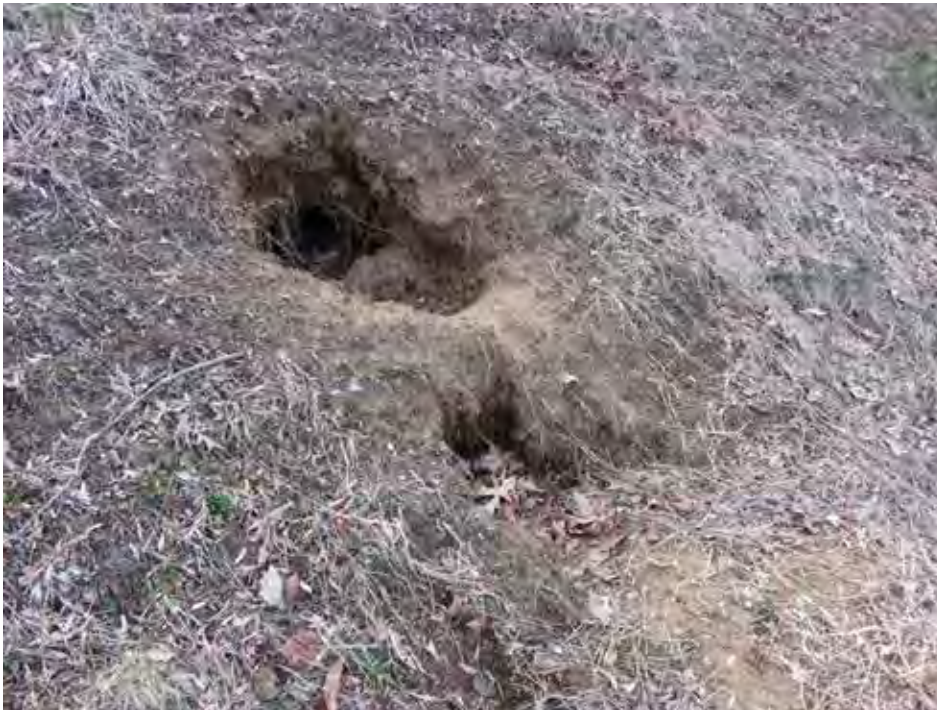
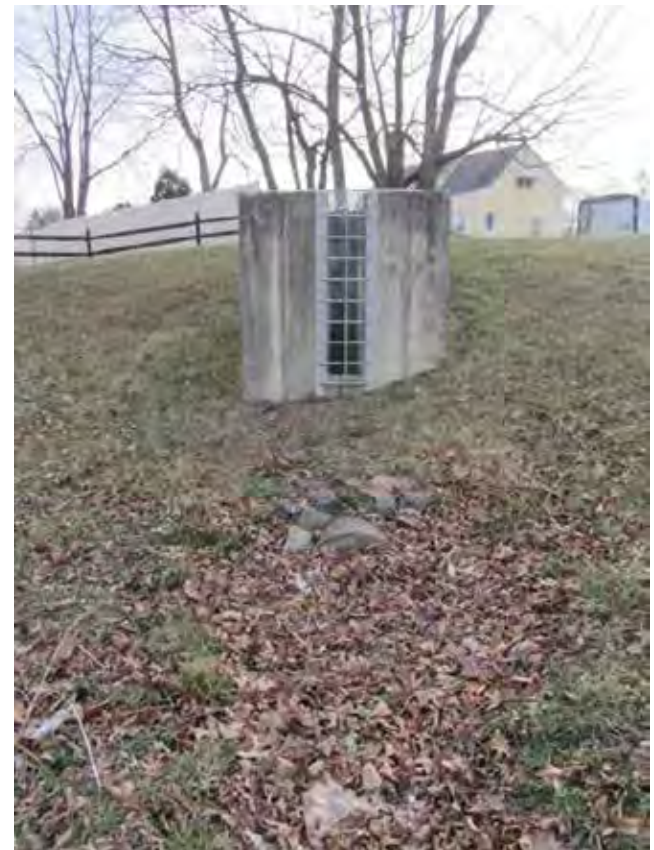
Stabilization and Erosion Control Repairs

- Ensure basin designs due not incorporate steep embankments (greater than 3:1)
- Maintain healthy groundcovers by not mowing basin areas to less than 4 inches in height

- Stabilization and erosion control repairs
 - Ensure basin designs do not incorporate steep embankments (greater than 3:1)
 - Maintain healthy groundcovers by not mowing basin areas to less than 4 inches in height
- Sediment removal
 - Install manufactured pre-treatment device prior to stormwater discharging to basins
 - Install a settling forebay near inlets where access can be provided and reached with available excavation equipment
- Outlet repair or replacement
 - Conduct regular inspections to ensure system is functioning properly and debris and litter are not clogging the outlet
 - Provide and maintain clear access to all structures of the system
