MS4 Permit Requirements and Inspection/Maintenance of Stormwater Management Facilities

Presented to Hamilton Township

Rutgers Cooperative Extension Water Resources Program
Chris Obropta and Matt Lecone

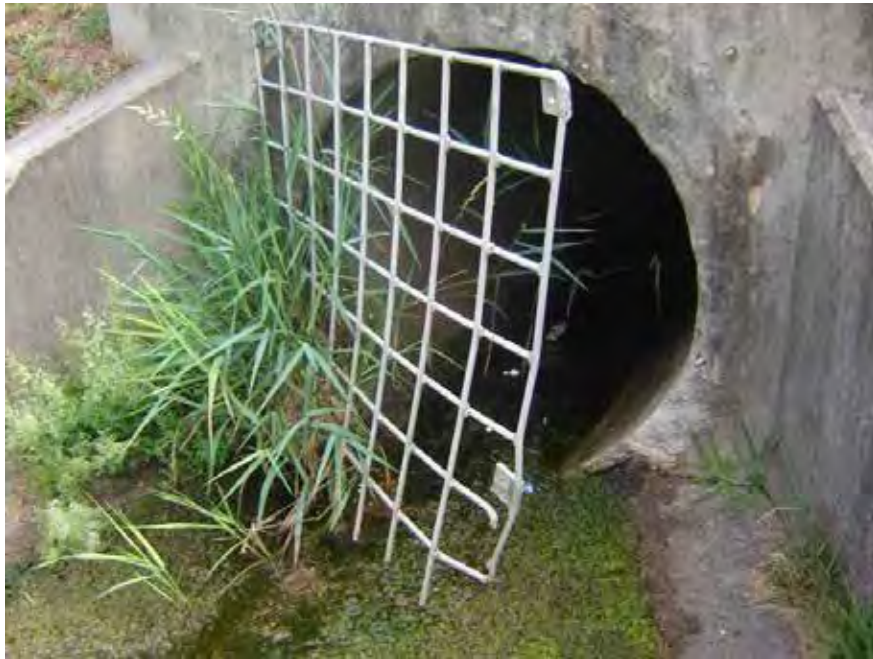
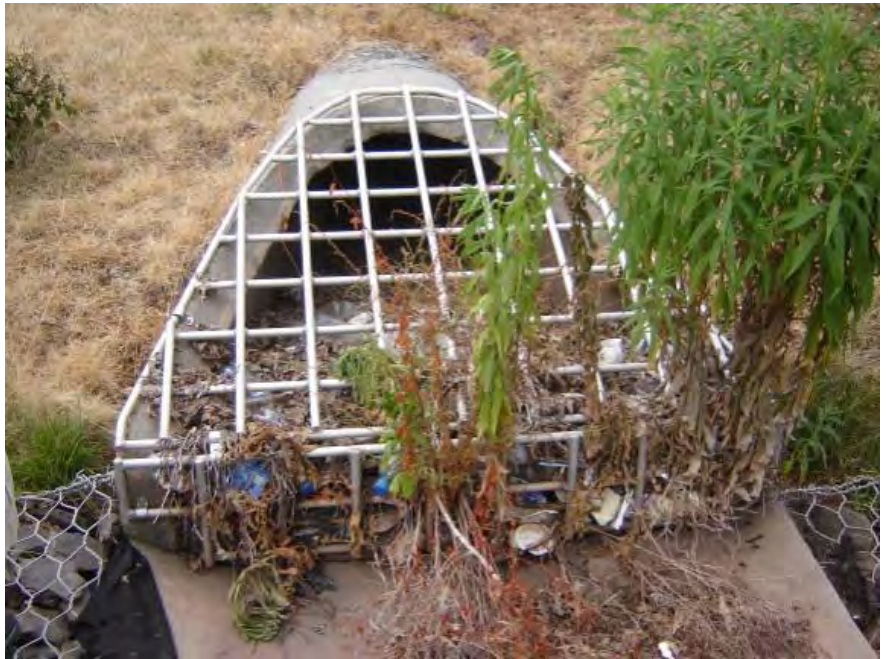
Outlet Repair or Replacement

- Conduct regular inspections to ensure system is functioning properly and debris and litter are not clogging the outlet
- Provide and maintain clear access to all structures of the system
